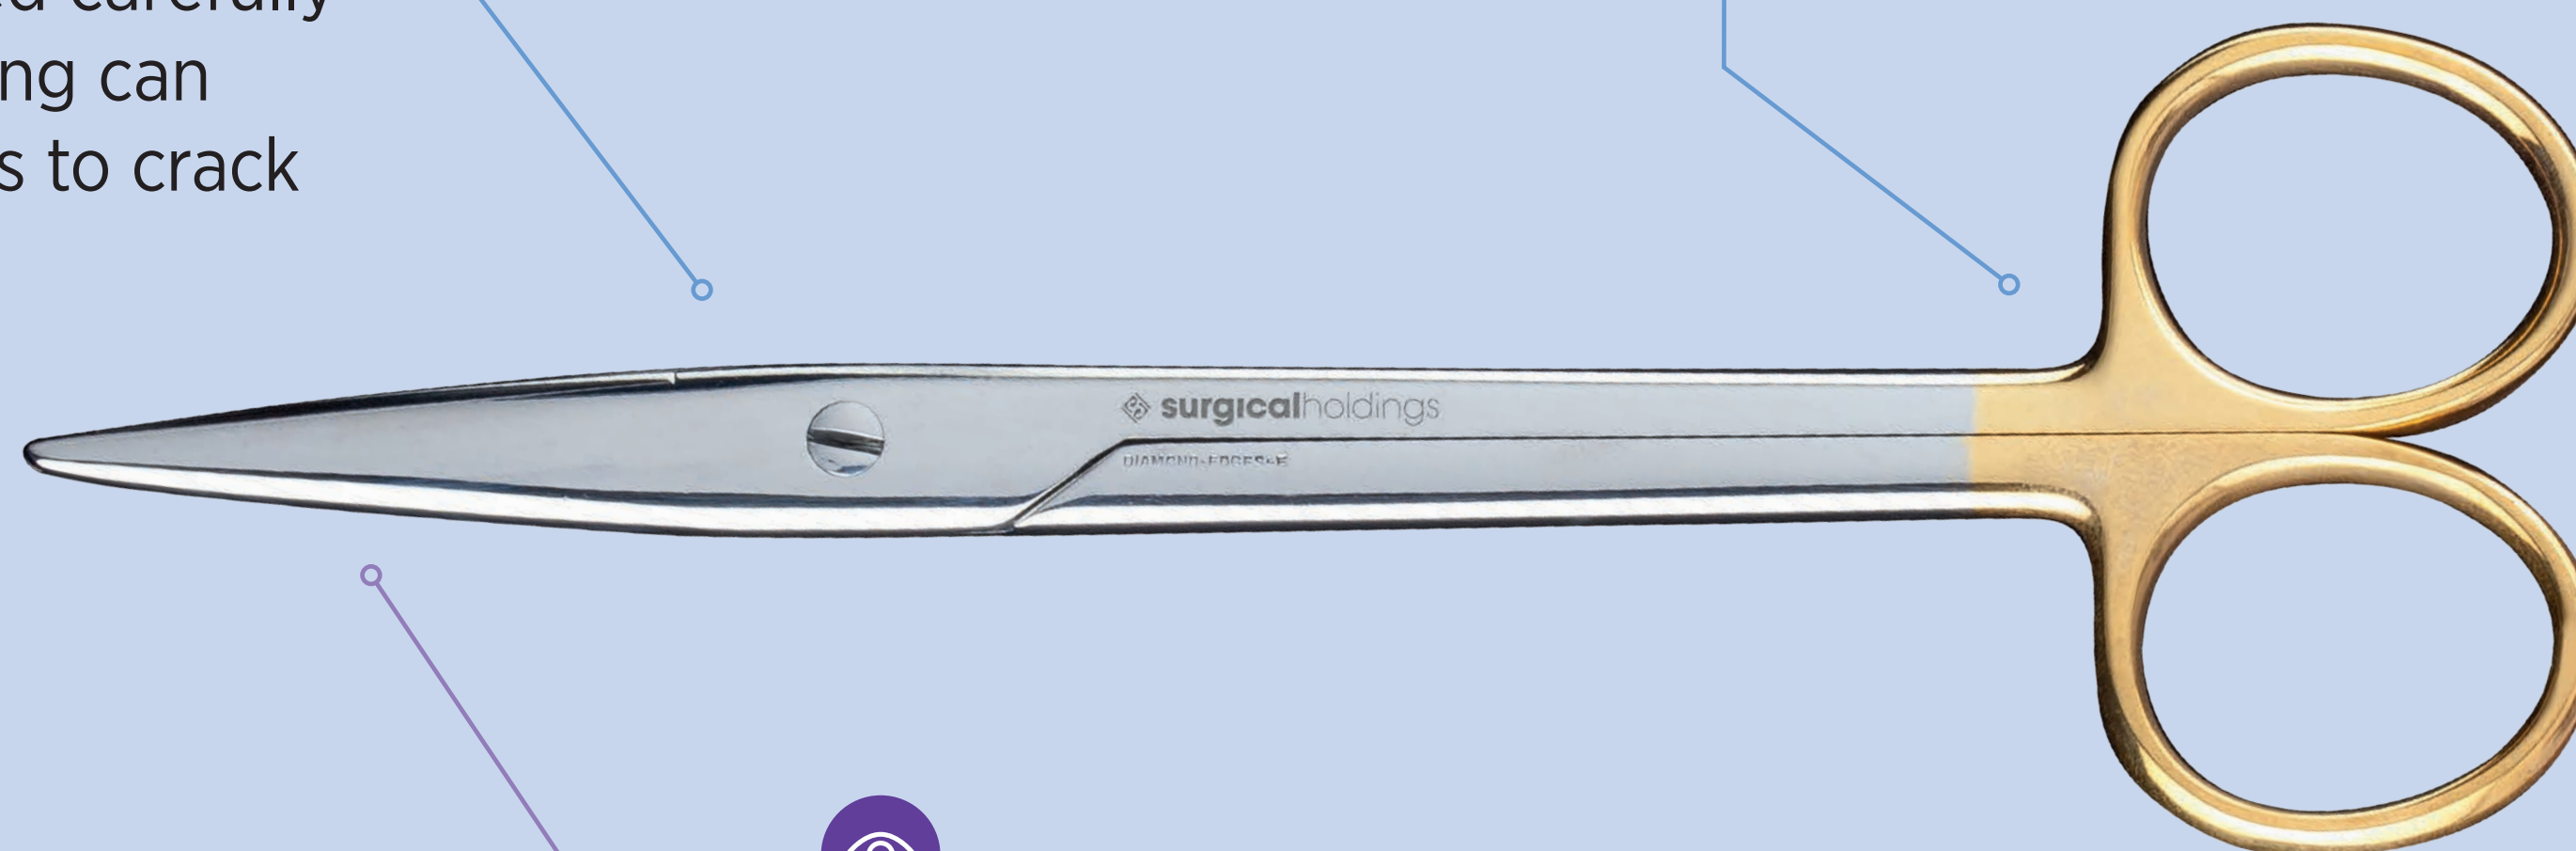
The two gold bows indicate the presence of Tungsten carbide - this is brazed into the jaw ensuring scissors are more durable and harder

Check that there is no cracking around this brazing and visually spot the faint line of the tungsten carbide along the scissor jaw

These scissors must be sharpened carefully as overheating can cause inserts to crack
